Appendix F.1 Pine Street Safety Audit

Town of Pinedale Transportation Master Plan

U.S. 191 (WY-13/Pine Street) MP 98.75-101.10 Safety Assessment Report Pinedale, Wyoming

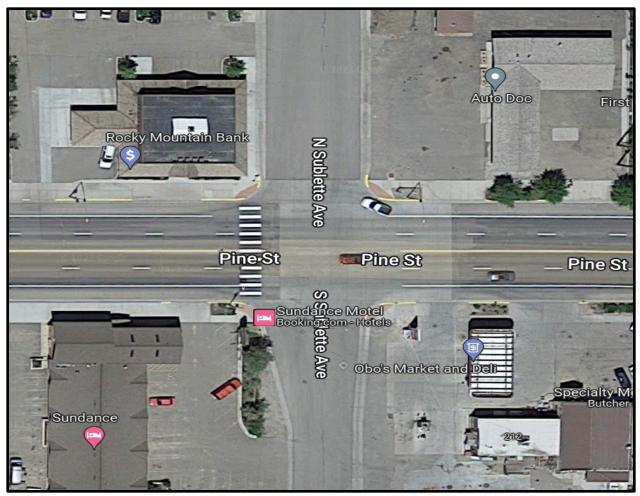
Figure 7: Sublette Avenue & US-191 (Pine St.)

Crash records revealed that both Broadside crashes occurred in adverse weather with slush and snow on the road. All crashes, including the Pedestrian incident occurred in daylight conditions. There is a striped pedestrian crosswalk on the west side of the intersection, but this intersection does not have actuated beacons like Lake Avenue and

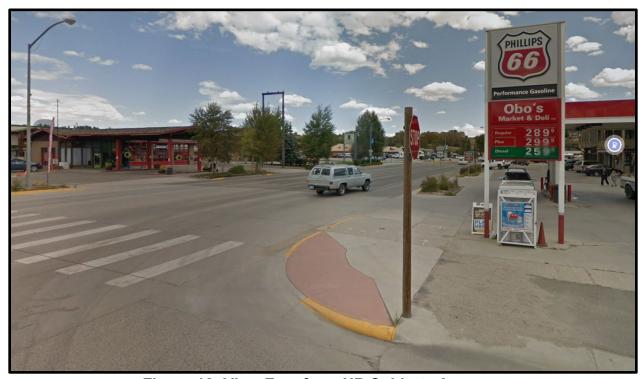
Google Streetview imagery shows there is a gas station on the southeastern corner of the intersection with two driveway accesses near the intersection (**Figure 12**). It is possible that northbound vehicles on Sublette Avenue may encounter visual obstructions due to traffic entering and exiting the gas station. Driveways are similarly located on the northeast and southwest corners of the intersection. In addition to the potential for visual obstruction, driveways located immediately adjacent to intersections may lead to misinterpretations of the intentions of drivers who are signaling to turn into a driveway on the far side of the intersection – drivers waiting to cross may think the signaling driver intends to turn onto Sublette Avenue.

Figure 12: View East from NB Sublette Avenue

With 2 broadside crashes, both occurring in adverse weather conditions in the study period, these might be regarded as over-represented or emerging patterns for observation.

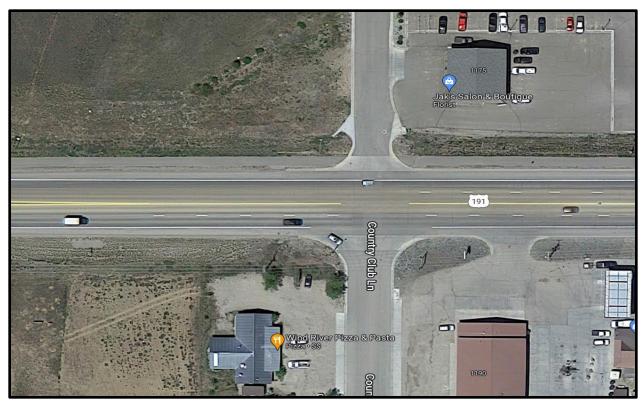
Figure 18: Country Club Lane & US 191 (Pine St.)

While crash records show there is nothing to indicate a trend for the injury collisions, when all crashes are considered, it is evident that in 3 out of the 4 cases adverse weather and road conditions were involved. In these 3 cases there was snow on the roadway, and in the case of the broadside collision it was also actively snowing at the time.

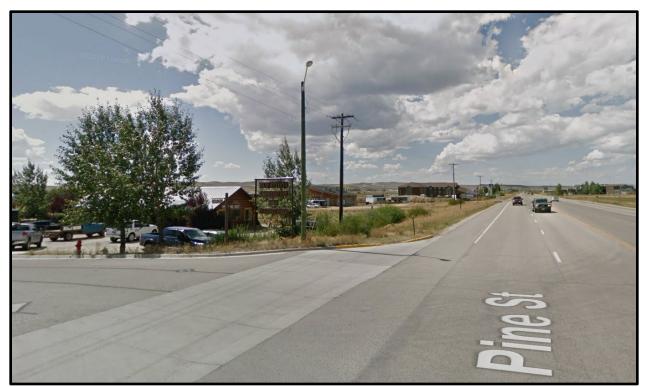
Furthermore, 2 of the 4 crashes occurred under dark conditions. Google Streetview imagery is available from 2015 and indicates that there is no streetlighting in the vicinity aside from one intersection luminaire in the southwest corner of the intersection (**Figure 23**).

Figure 23: Single Luminaire on SW Corner of US 191 & Country Club Ln

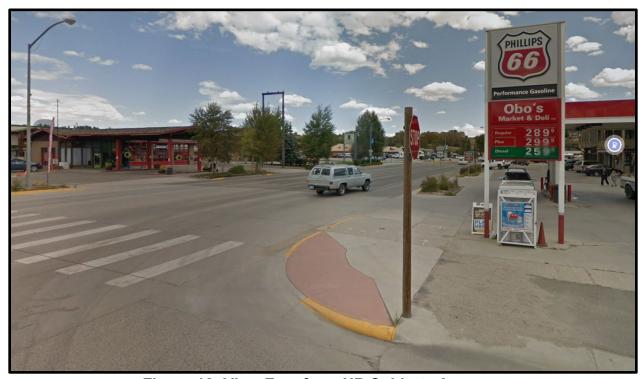
Google Streetview imagery shows there is a gas station on the southeastern corner of the intersection with two driveway accesses near the intersection (**Figure 12**). It is possible that northbound vehicles on Sublette Avenue may encounter visual obstructions due to traffic entering and exiting the gas station. Driveways are similarly located on the northeast and southwest corners of the intersection. In addition to the potential for visual obstruction, driveways located immediately adjacent to intersections may lead to misinterpretations of the intentions of drivers who are signaling to turn into a driveway on the far side of the intersection – drivers waiting to cross may think the signaling driver intends to turn onto Sublette Avenue.

Figure 12: View East from NB Sublette Avenue

With 2 broadside crashes, both occurring in adverse weather conditions in the study period, these might be regarded as over-represented or emerging patterns for observation.

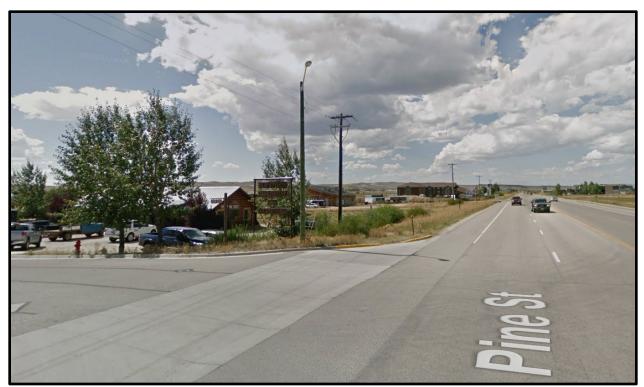
While crash records show there is nothing to indicate a trend for the injury collisions, when all crashes are considered, it is evident that in 3 out of the 4 cases adverse weather and road conditions were involved. In these 3 cases there was snow on the roadway, and in the case of the broadside collision it was also actively snowing at the time.

Furthermore, 2 of the 4 crashes occurred under dark conditions. Google Streetview imagery is available from 2015 and indicates that there is no streetlighting in the vicinity aside from one intersection luminaire in the southwest corner of the intersection (**Figure 23**).

Figure 23: Single Luminaire on SW Corner of US 191 & Country Club Ln
