Appendix F.1 Pine Street Safety Audit

Town of Pinedale Transportation Master Plan

U.S. 191 (WY-13/Pine Street) MP 98.75-101.10 Safety Assessment Report Pinedale, Wyoming

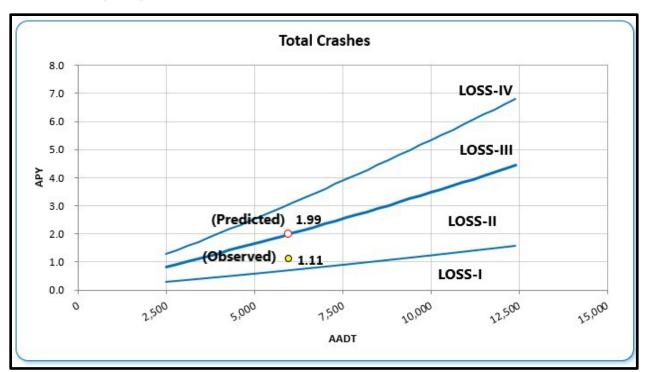
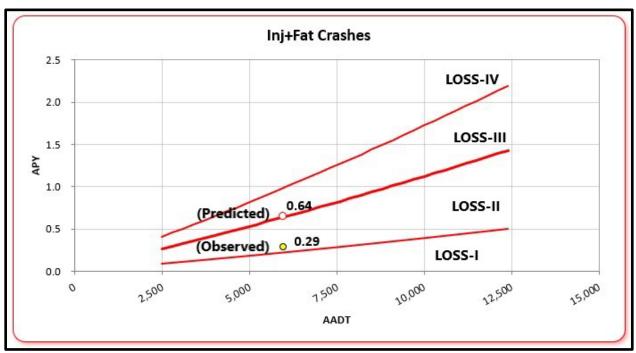
Figure 2 and **Figure 3** represent EB corrected segment level safety performance of US-191 within the study limits. The SPF model is focused on multi-vehicle crashes primarily, as such we have removed all Wild Animal Collisions from the model to quantify the effect of alignment and typical section on safety performance. **Figure 2** shows that safety performance from the total crash frequency standpoint (excluding collisions with wild animals), is in LOSS-II, reflecting low to moderate potential for crash reduction for the segment. **Figure 3** represents safety performance from the standpoint of severity and considers injury and fatal crashes only (excluding 1 injury crash with a deer). It also shows that the segment performs at LOSS-II, reflecting low to moderate potential for crash reduction.

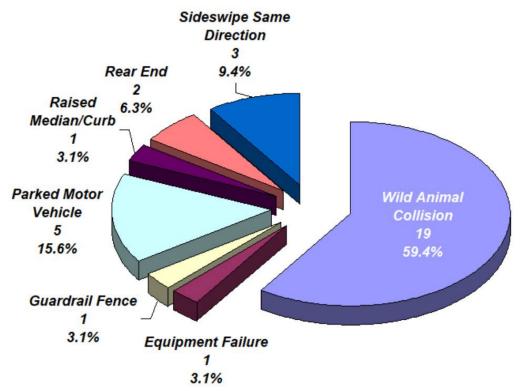
Figure 4: US-191 MP 98.75-101.10 Crash Distribution by Type

Distribution of crashes by type on the mainline of US-191 within the study limits is provided in **Figure 4**. The most frequent crash type is collisions with wild animals, followed by collisions with parked motor vehicles.

As outlined above, the SPF model for an Urban 4-lane Undivided Arterial is best adapted to multi-vehicle collisions, and furthermore at this time diagnostic tools for this facility type have not been developed. In this case, while we cannot use diagnostic tools, we can make observations based on crash history.

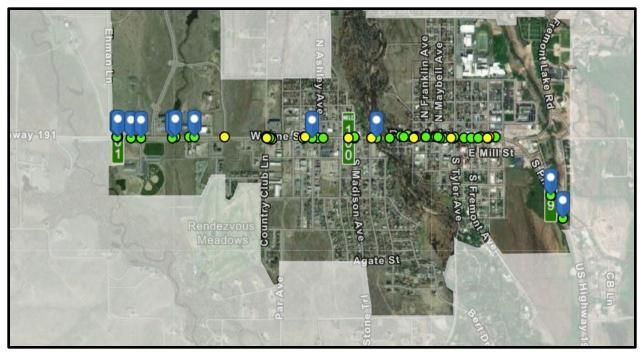
Figure 5: Wild Animal Collisions (BLUE) on US-191, 1/1/16-12/31/21

In the case of Wild Animal collisions, we can say that by observation they constitute a pattern since we do not expect more than half of crashes on an urban arterial to involve wild animals. Crash records show that WACs tend to be concentrated at the eastern and western side of downtown, with a cluster around MP 98.8 and a cluster around MP 100.75-101.00. **Figure 5** shows where WACs were recorded, identified by the blue markers. There is a creek to the west of MP 101.00, and a stream adjacent to Bloomfield Avenue near MP 100.75, both of which would provide a water source for wild animals. Similarly, there is a ditch associated with the cluster west of MP 100. Pine Creek is also associated with a cluster and Pine Ditch is nearly adjacent to the cluster at the east end of the study. Only 1 wild animal collision resulted in a reported injury (a collision with a deer at MP 98.78).

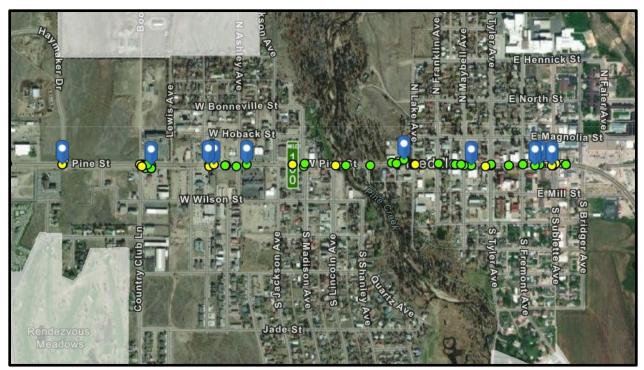
Figure 6: General Locations of Driveway Access Crashes (BLUE), US-191, 1/1/16-12/31/21

between Sublette Avenue and Haymaker Drive, MP 99.398 to MP 100. 540, approximately (**Figure 6**). There is mild clustering to driveway accesses crashes, with only 2 mid-block locations seeing 2 or more crashes: Sublette Avenue to Fremont Avenue, and Ashley Avenue to Colter Avenue.

Although diagnostic tools are not available, we can say by observation that Injury level Driveway Access crashes constitute a pattern here, with 7 injuries occurring over a 6 year period, meeting the basic definition of cumulative binomial probability, exceeding 95% and a minimum of 5 crashes of a given type or category in a 5 year period.

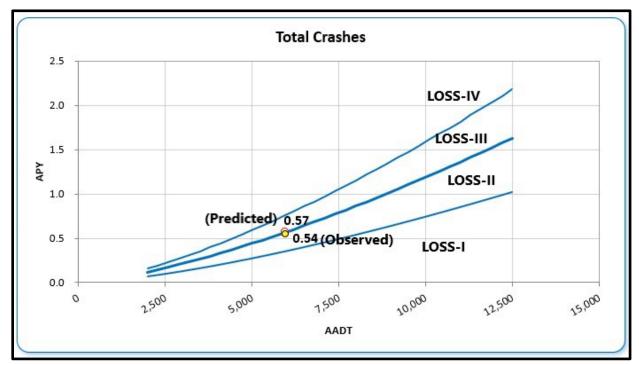
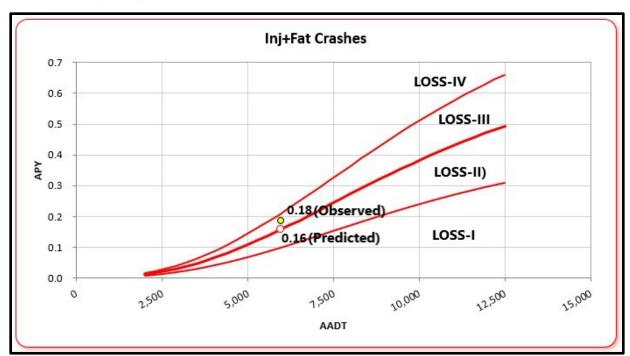
Figure 9 and **Figure 10** represent EB corrected intersection level safety performance of the intersection of Sublette Ave and US 191. **Figure 9** shows safety performance from the total crash frequency standpoint, reflecting LOSS-II (low to moderate potential for crash reduction) for the intersection, with performance better than the expected mean for this facility type. **Figure 10** represents safety performance from the standpoint of severity and considers injury and fatal crashes only. It shows that the intersection performs at LOSS-III, reflecting moderate to high potential for crash reduction.

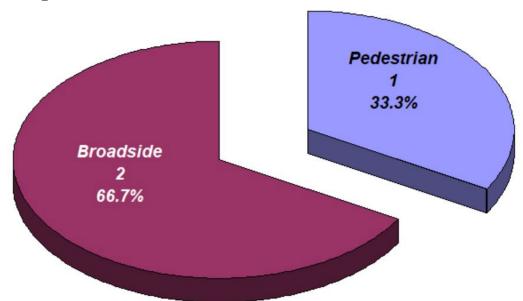
Figure 11: US 191 & Sublette Avenue Crash Distribution by Type

Crash records revealed that both Broadside crashes occurred in adverse weather with slush and snow on the road. All crashes, including the Pedestrian incident occurred in daylight conditions. There is a striped pedestrian crosswalk on the west side of the intersection, but this intersection does not have actuated beacons like Lake Avenue and

With 2 broadside crashes, both occurring in adverse weather conditions in the study period, these might be regarded as over-represented or emerging patterns for observation.

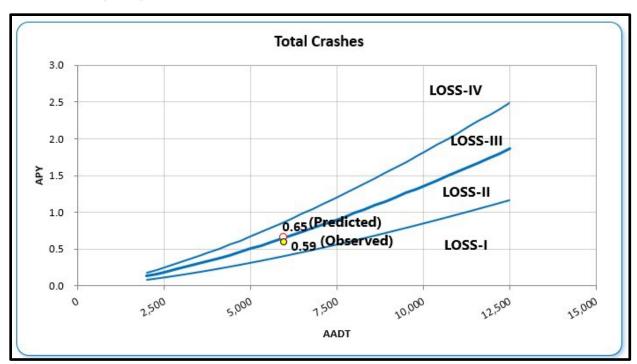
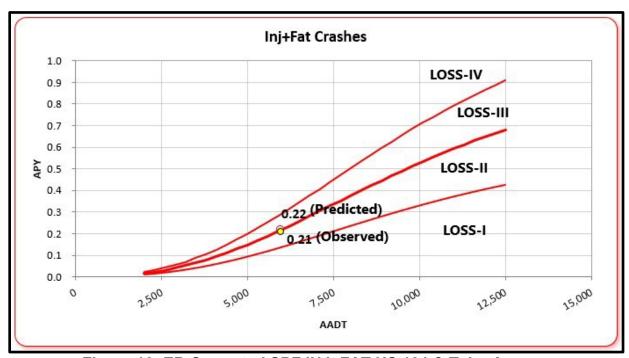
Figure 15 and **Figure 16** represent EB corrected intersection level safety performance of the intersection of Tyler Ave and US 191. **Figure 15** shows safety performance from the total crash frequency standpoint, while **Figure 16** represents safety performance from the standpoint of severity and considers injury and fatal crashes only. **Figure 15** shows that the intersection performs at LOSS-II from the total crash frequency standpoint, reflecting low to moderate potential for crash reduction. **Figure 16** shows the intersection performs near the mean from the crash severity standpoint, reflecting moderate potential for crash reduction.

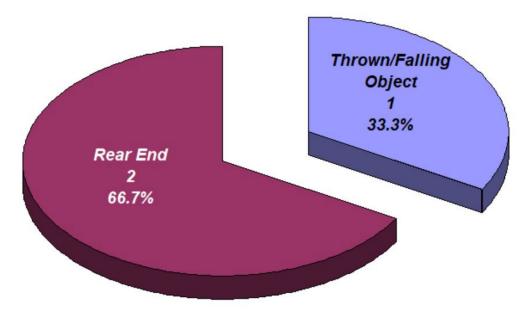
Figure 17: US 191 & Tyler Avenue Crash Distribution by Type

As outlined previously because no crash type or category met the definition of a pattern for cumulative binomial probability, there are no identified patterns which can be evaluated by direct diagnostics.

The "Thrown/Falling Object" crash was a single vehicle incident and occurred on July 4th, such that it is potentially related to festivities. All crashes occurred in daylight conditions and without any adverse road or weather conditions.

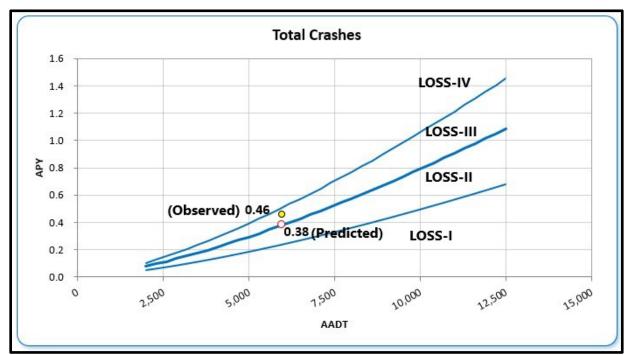
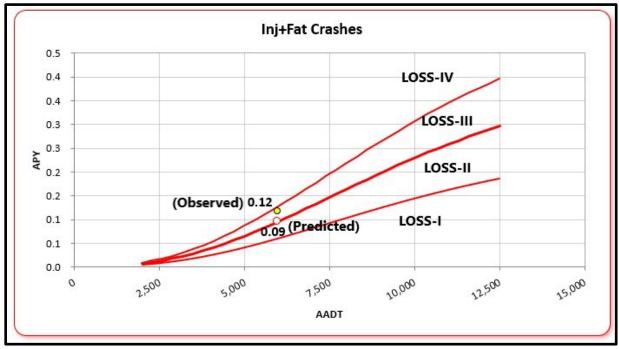
Figure 20 and **Figure 21** represent EB corrected intersection level safety performance of the intersection of Country Club Lane and US 191. **Figure 20** shows safety performance from the total crash frequency standpoint, while **Figure 21** represents safety performance from the standpoint of severity and considers injury and fatal crashes only. The figures

show that the intersection performs at LOSS-III, from both the total crash frequency and the crash severity standpoints, reflecting moderate to high potential for crash reduction.

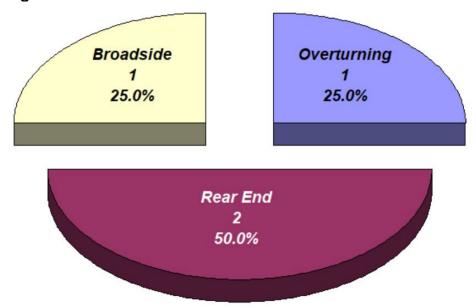
Figure 22: US 191 & Country Club Lane Crash Distribution by Type

As outlined previously because no crash type or category met the definition of a pattern for cumulative binomial probability, there are no identified patterns which can be evaluated by direct diagnostics. However, SPF analysis showed that injury crashes are elevated above expected norms at the intersection. There were 2 injury crashes at the intersection with 3 injuries, one crash was a Rear-End collision and the other was a Broadside collision. In addition, there was a PDO Rear-End collision and a PDO Overturning collision.

While crash records show there is nothing to indicate a trend for the injury collisions, when all crashes are considered, it is evident that in 3 out of the 4 cases adverse weather and road conditions were involved. In these 3 cases there was snow on the roadway, and in the case of the broadside collision it was also actively snowing at the time.

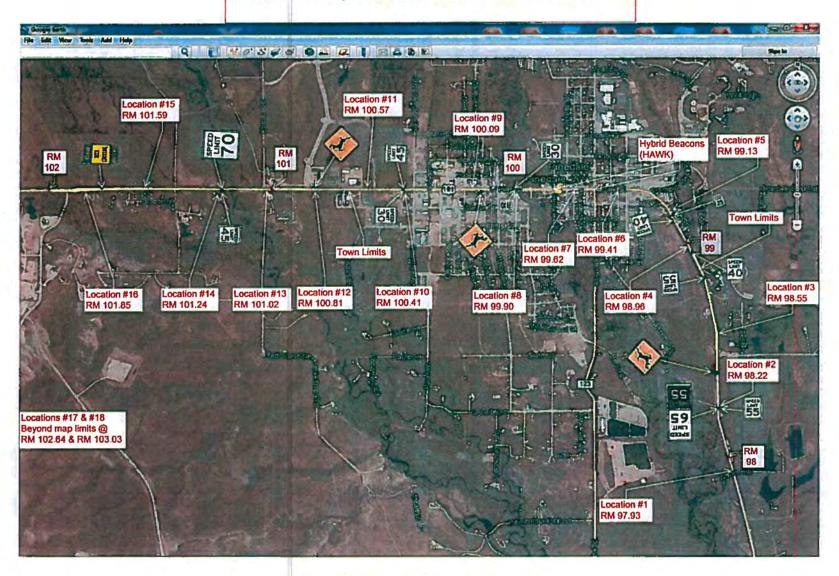
EXHIBIT 2 - Speed Data Collection Locations

For the section of roadway south of Pinedale and south of Fayette Pole Creek Road, as shown in the table for Location #1 above, the 85^{th} -percentile speeds were 1 mph below to 5 mph above, and the upper limit of the pace were 2 mph below and 3 mph above the posted speed limit of 70-mph. (Data was collected 9/28/16 whereas the reduced nighttime speed limit was installed 10/20/16). The speed data collected in this area indicates that motorists consider this section of roadway as a completely rural highway, as indicated by the 85^{th} -percentile speed being between 69 and 75 mph, and the pace being 59-68 mph and 64-73 mph, northbound and southbound respectively. Based on a review of the area, the roadway environment is completely rural just south of

Fayette Pole Creek Road. Based on the speed data, speed profile, speed compliance, and roadway environment in the area, the recommended speed limit from the speed study worksheets would be 70-mph.

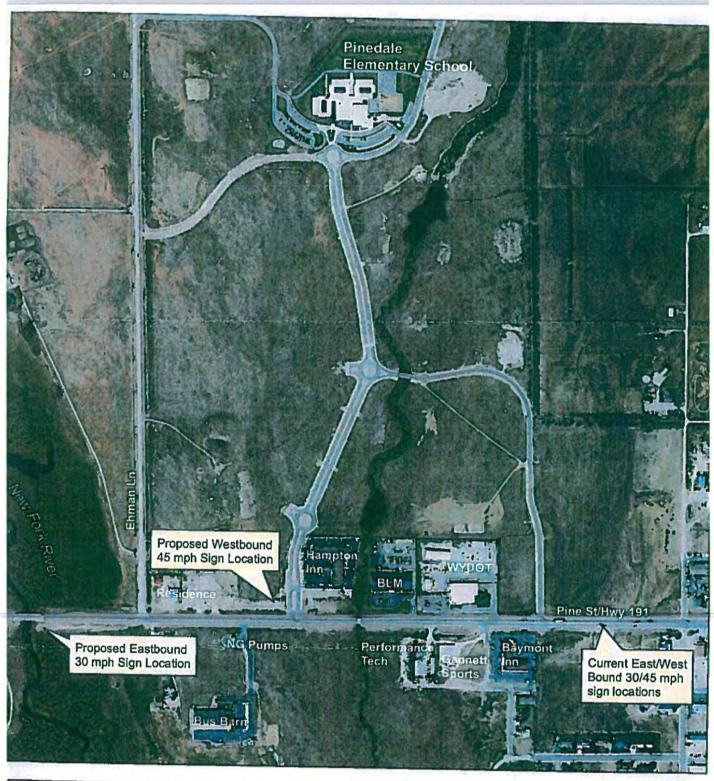
BLM - Proposed Speed Limit Sign Locations for Pine St/Hwy 191 through Pinedale WY

- The entryway to the Stromness Building, which has 75 employees (BLM, SCCD, and NRCS), was identified as a safety issue during an Annual Safety Audit. Because Highway 191/Pine Street changes from four lanes to one lane each way east of this area and because of the bike path, there is no room for a right turn lane. Accelerating westbound traffic often does not slow down for turning traffic. This is further complicated by the several commercial businesses in this area, including the local WYDOT office, two motels, a car repair shop, a school bus barn, and a Natural Gas (NG) pump station (used by NG school buses to obtain fuel). Mitigations to date have not solved the problems which worsened during winter.

The Bureau of Land Management (BLM) Pinedale Field Office (PFO) requests that the Wyoming Department of Transportation (WYDOT) reduce the speed limit from 45 mph to 30 mph on west Pine Street in Pinedale. We recommend that the speed limit signs be moved as follows (see attached map):

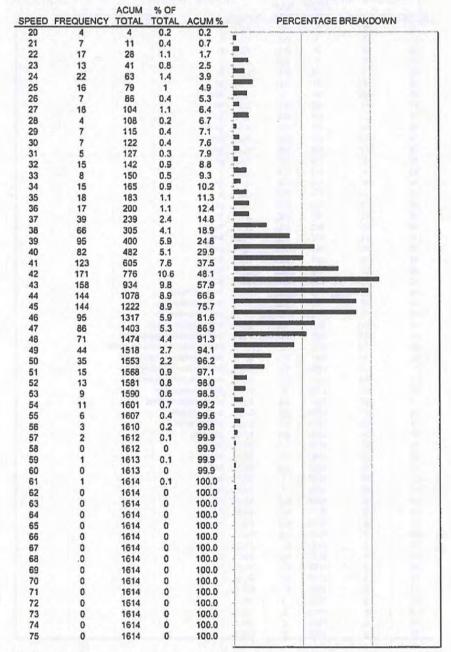
ROUTE: US 191 LOCATION: RM WEATHER: COMMENTS: Jamar Radar

AVERAGE SPEED = 41.8 50th PERCENTILE = 43 67th PERCENTILE = 45

85th PERCENTILE = 47 95th PERCENTILE = 50 PACE SPEED = 39 to 48 VEHICLES IN PACE = 1169 % IN PACE = 72 % BELOW PACE = 19 % ABOVE PACE = 9

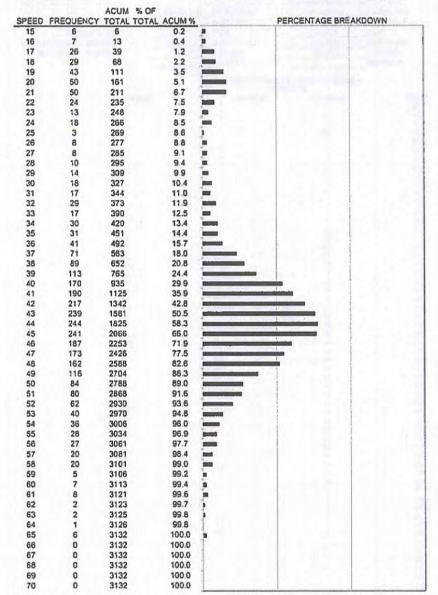
CITY: PINEDALE SPEED LIMIT: 45 MPH OBSERVER: 0 DATE: 9/29/16 & 9/30/16 COUNTY: SUBLETTE ROUTE: US 191
COMBINED: Northbound/SourLOCATION: RM 101.02 START TIME: 10:15 AM WEATHER: Varying conditions END TIME: 9:30 AM COMMENTS: Jamar Radar

AVERAGE SPEED = 42.0 50th PERCENTILE = 43 67th PERCENTILE = 46 85th PERCENTILE = 49 95th PERCENTILE = 54

PACE SPEED = 40 to 49 VEHICLES IN PACE = 1939 % IN PACE = 62 % BELOW PACE = 24 % ABOVE PACE = 14

STANDARD DEVIATION = 8.77 % EXCEEDING POSTED LIMIT = 34 RECOMMENDED SPEED LIMIT = 50
